**VOLA RS11/1/2/3**

Date  
Aug. 21

Sheet  
**SB 118**

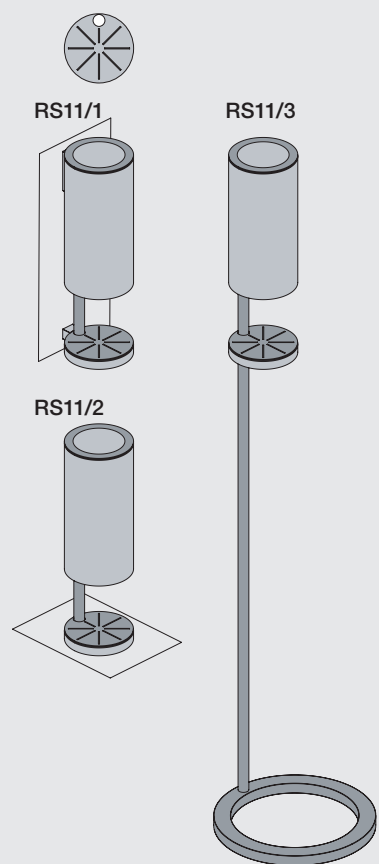
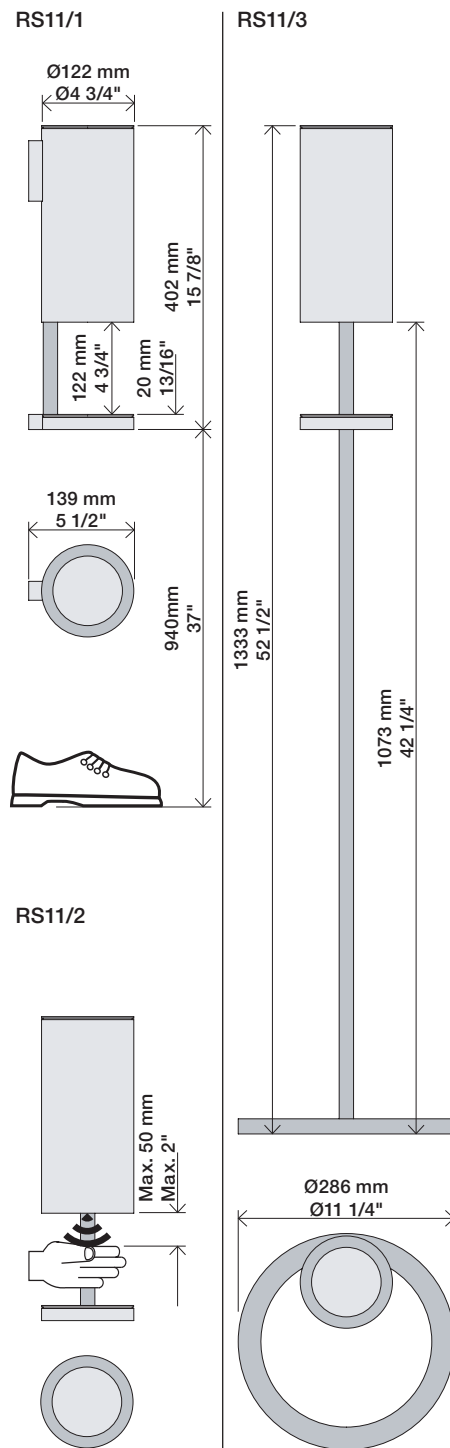
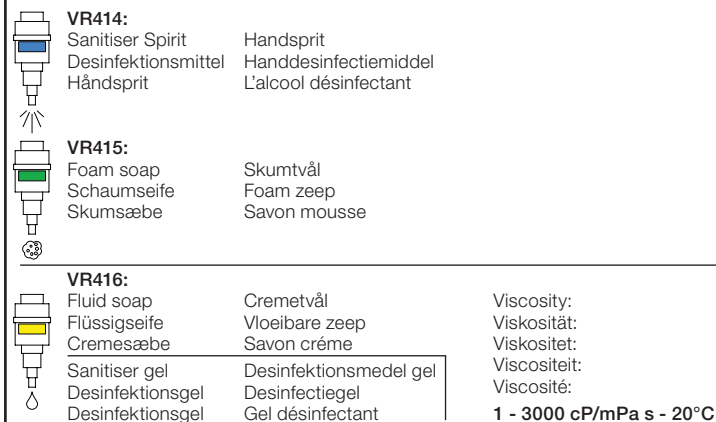
Sunlight or light from halogen lamps  
can disturb the sensor.

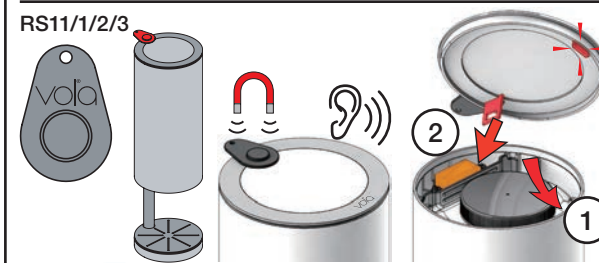
Service mode:  
Servicemodus:  
Servicetilstand: **OFF**  
Serviceläge:  
Onderhoudsinstelling:  
Mode de service:

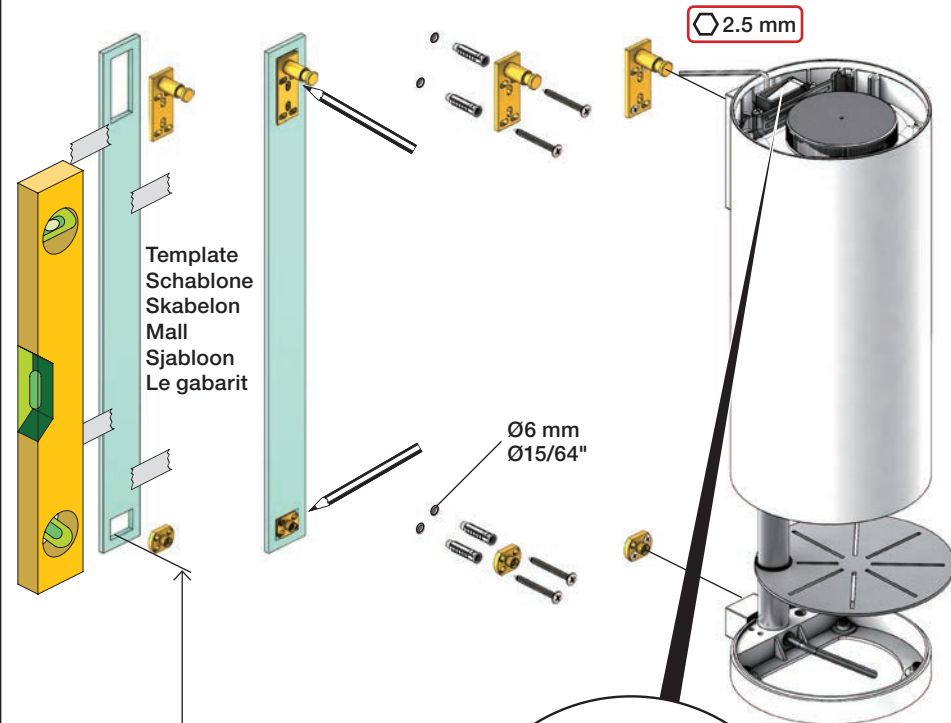
Recommended height  
Empfohlene Höhe  
Anbefalet højde  
Rekommenderad höjd  
Aanbevolen hoogte  
Hauteur recommandée

940mm  
37"

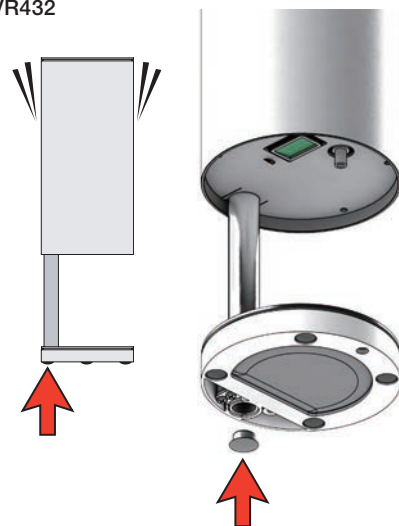
RS11/1/2/3

Theft protection  
Diebstahlsicherung  
Tyverisikring

Stölskydd  
Anti diefstal  
Antivol
